August 5, 2002

**Subject: Report of Structural Engineering Evaluation – ADDENDUM 1
Second Elevated Floor Slab and Stage Framing
Italian Club
Ybor City
Tampa, Florida**

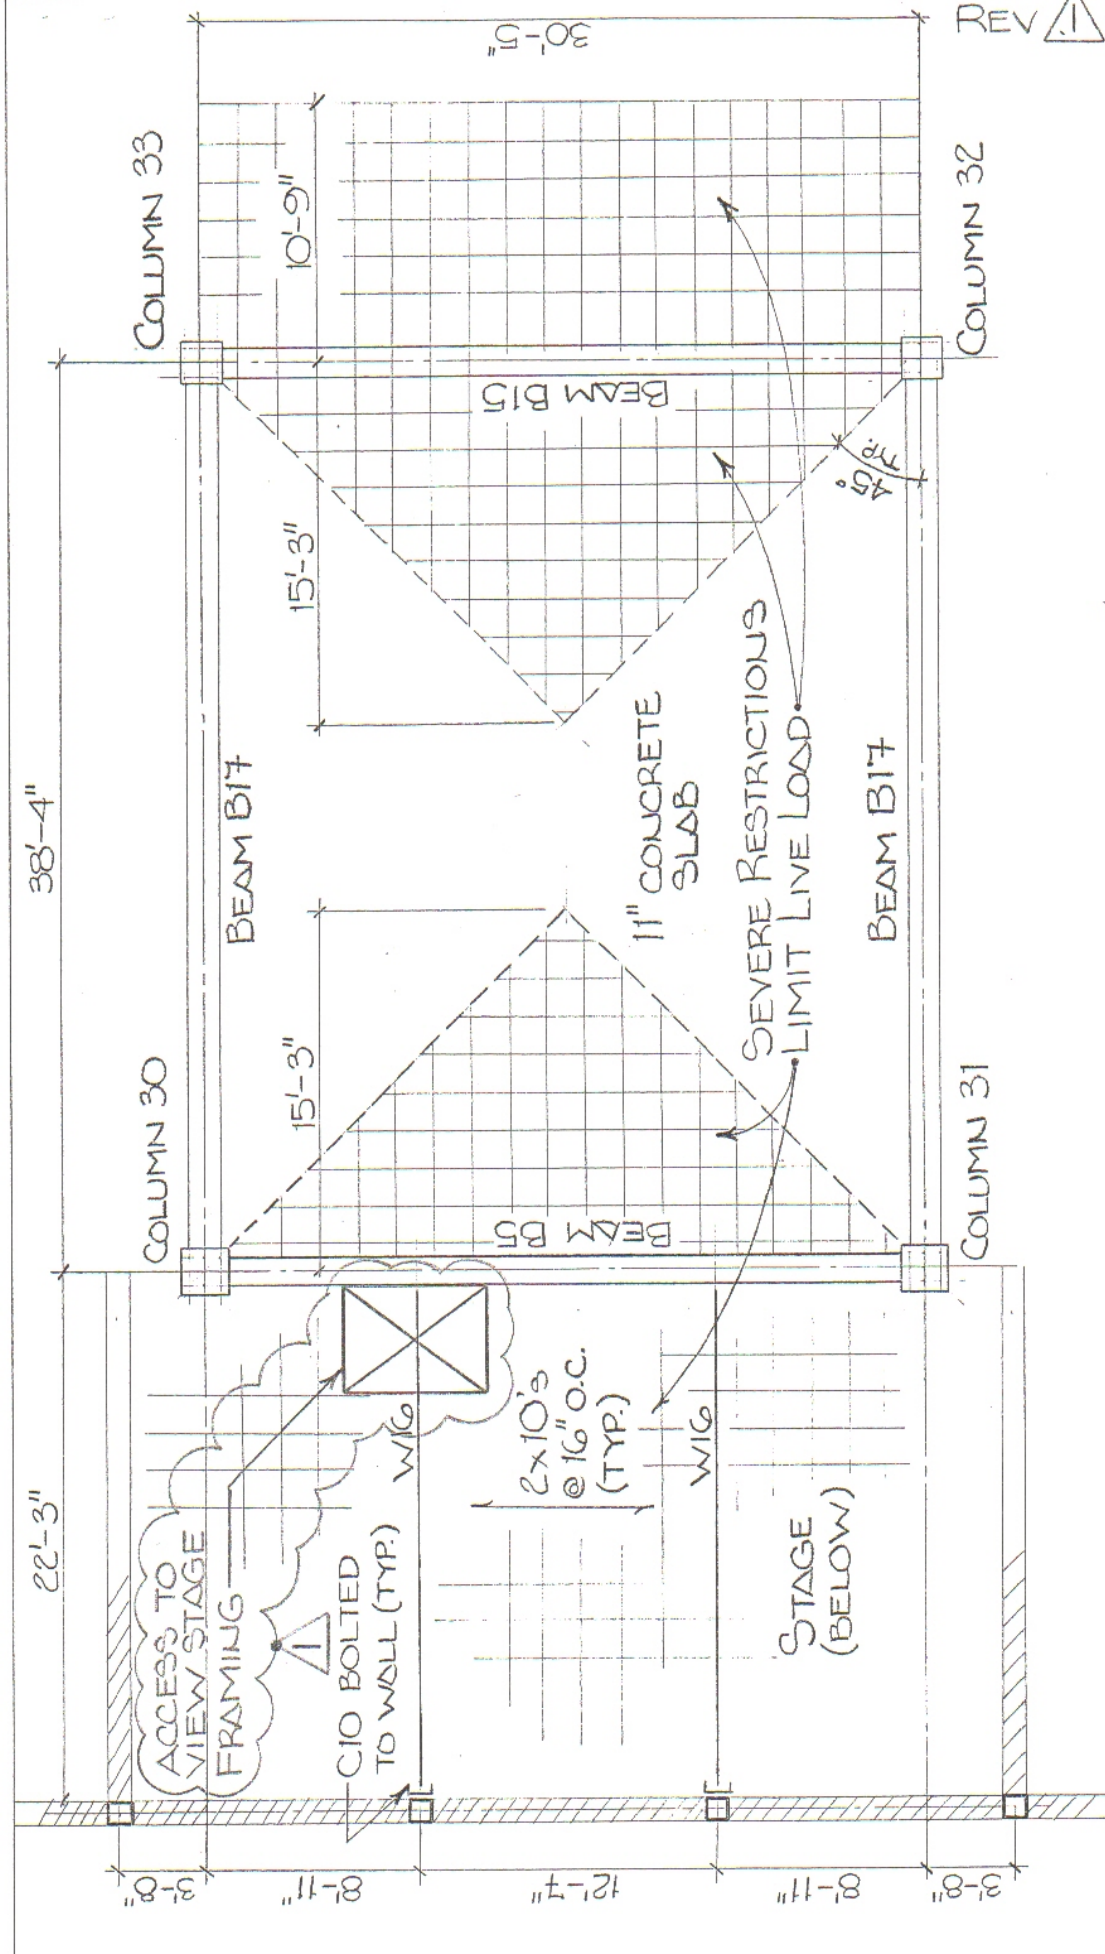
PARTIAL PLAN - 2ND ELEVATED FLOOR SLAB/BALLROOM
N.T.S.

Biller Reinhardt Structural Group, Inc. (BRSBG) has previously completed a limited condition survey and evaluation of the second elevated floor slab and its associated structural elements in the ballroom of the building bounded by Columns 30, 31, 32 and 33 and the adjacent stage area framing. Our report issued May 24, 2002, had the following conclusions (please refer to attached Partial Plan):

- c. The wide flange steel beams supporting the wood joists appear to connect into Beam B5, and BRSB has concerns with this beam (see item below).
- d. BRSB has concerns regarding Beam B5, which spans east-west between columns 30 and 31. This beam appears to have been originally designed for the partial support of the 11 inch thick concrete slab and its associated loading. The upper stage area was originally open to the stage below at the auditorium level. BRSB believes the additional stage framing and its associated loading significantly overstresses the beam beyond current building code requirements. No drawings or information are available for review regarding the stage framing, so BRSB is unable to determine if additional reinforcement was applied to Beam B5 before the additional stage area framing was installed.

In addition to the 3rd Floor Stage drawing review, BRSG recommends removing a portion of the floor deck above the stage area framing to visually observed Beam B5 and the connection of the stage framing to this beam. See attached Partial Plan for recommend location for access.
